# **Conservation Portfolio**

### **Conservation Studies**

(Concepts, Project preparation, project management, Research and Documentation)

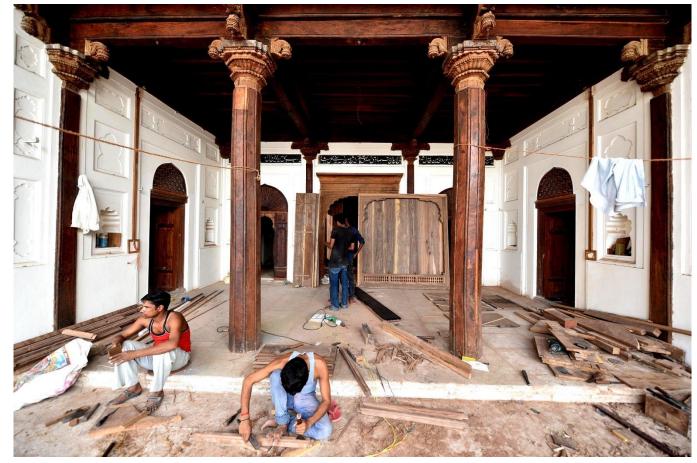
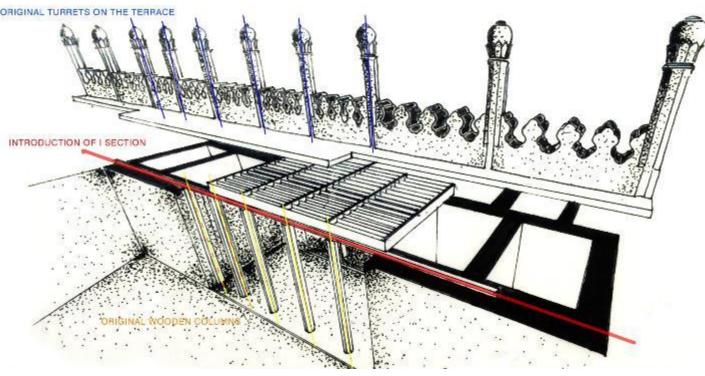
The Load of the turrets and roofing on original wooden columns is relieved by the introduction of I-sections above the columns. This intervention allowed us to retain the original wooden roofing.

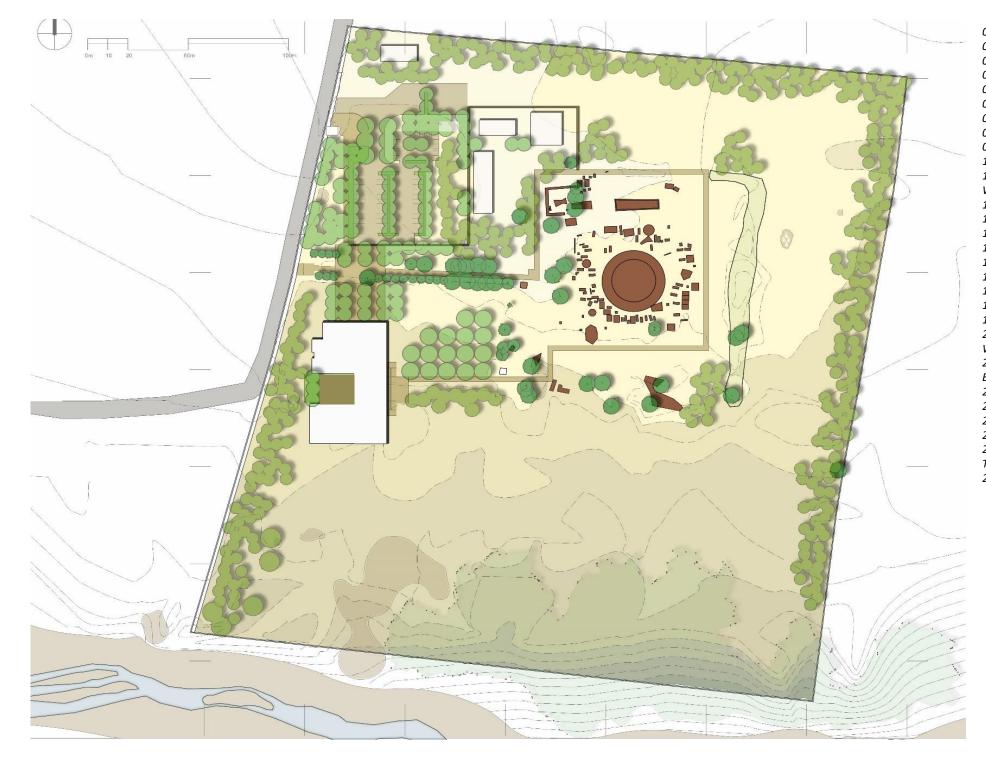
#### **PROPOSED MASTERPLAN-OP 1**

01 PROPOSED VEHICULAR GATE 02- SECURITY CABIN & PED. GATE 03- PEDESTRIAN PATH 04- BUS PARKING (4) 05- SERVICE BLOCK 06- TREE LINED -4W PARKING 07- TREE-LINED 2W PARKING 08-WICKET GATE & CORDON TOE WALL 09- ARRIVAL NODE 10- DIGNITARY GATE 11- EXISTING ACCESS TO STUPA WITH EXISTING TREES 12- TREE GROVE AS SCREEN 13- PERIMTER PLANTING- NATIVE TREES 14A- VISITOR BLOCK 14B- COLONNADED COURT 15- ENCLOSED COURTYARD 16- INTERPRETATION CENTRE 17- ACCESS TO STUPA (TRAIL START) **18- SCREEN PLANTING 19- SCREEN PLANTING** 20- RAMMED EARTH WALKWAY 2.5M WIDE 21- ENTRY TO SCULPTURE DISPLAY ENCLOSURES 22- SCULPTURE DISPLAY ENCLOSURES 23- WOODED THICKET & TOE WALL 24- ASHOKAN EDICT 25- RETURN PATH 26- CAFETARIA KIOSK IN WOODED THICKET 27- SERVICE BAY

Landscape development proposal by FICUS landscape consultants, Bangalore

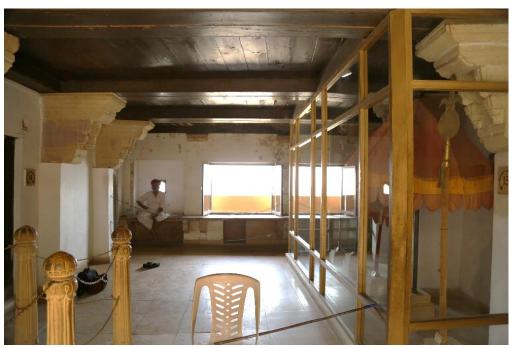
## **AKHEY VILAS**

Deteriorated wall and damaged wooden ceiling supports

Separation of bracket and cracks on wall
